## Arboricultural Report Pertaining To 220 Albany Creek Rd, Bridgeman Downs.

**Client:** TMR

**Site:** 220 Albany Creek Rd, Bridgeman Downs.

**Inspection Date:** 18 Feb 2022

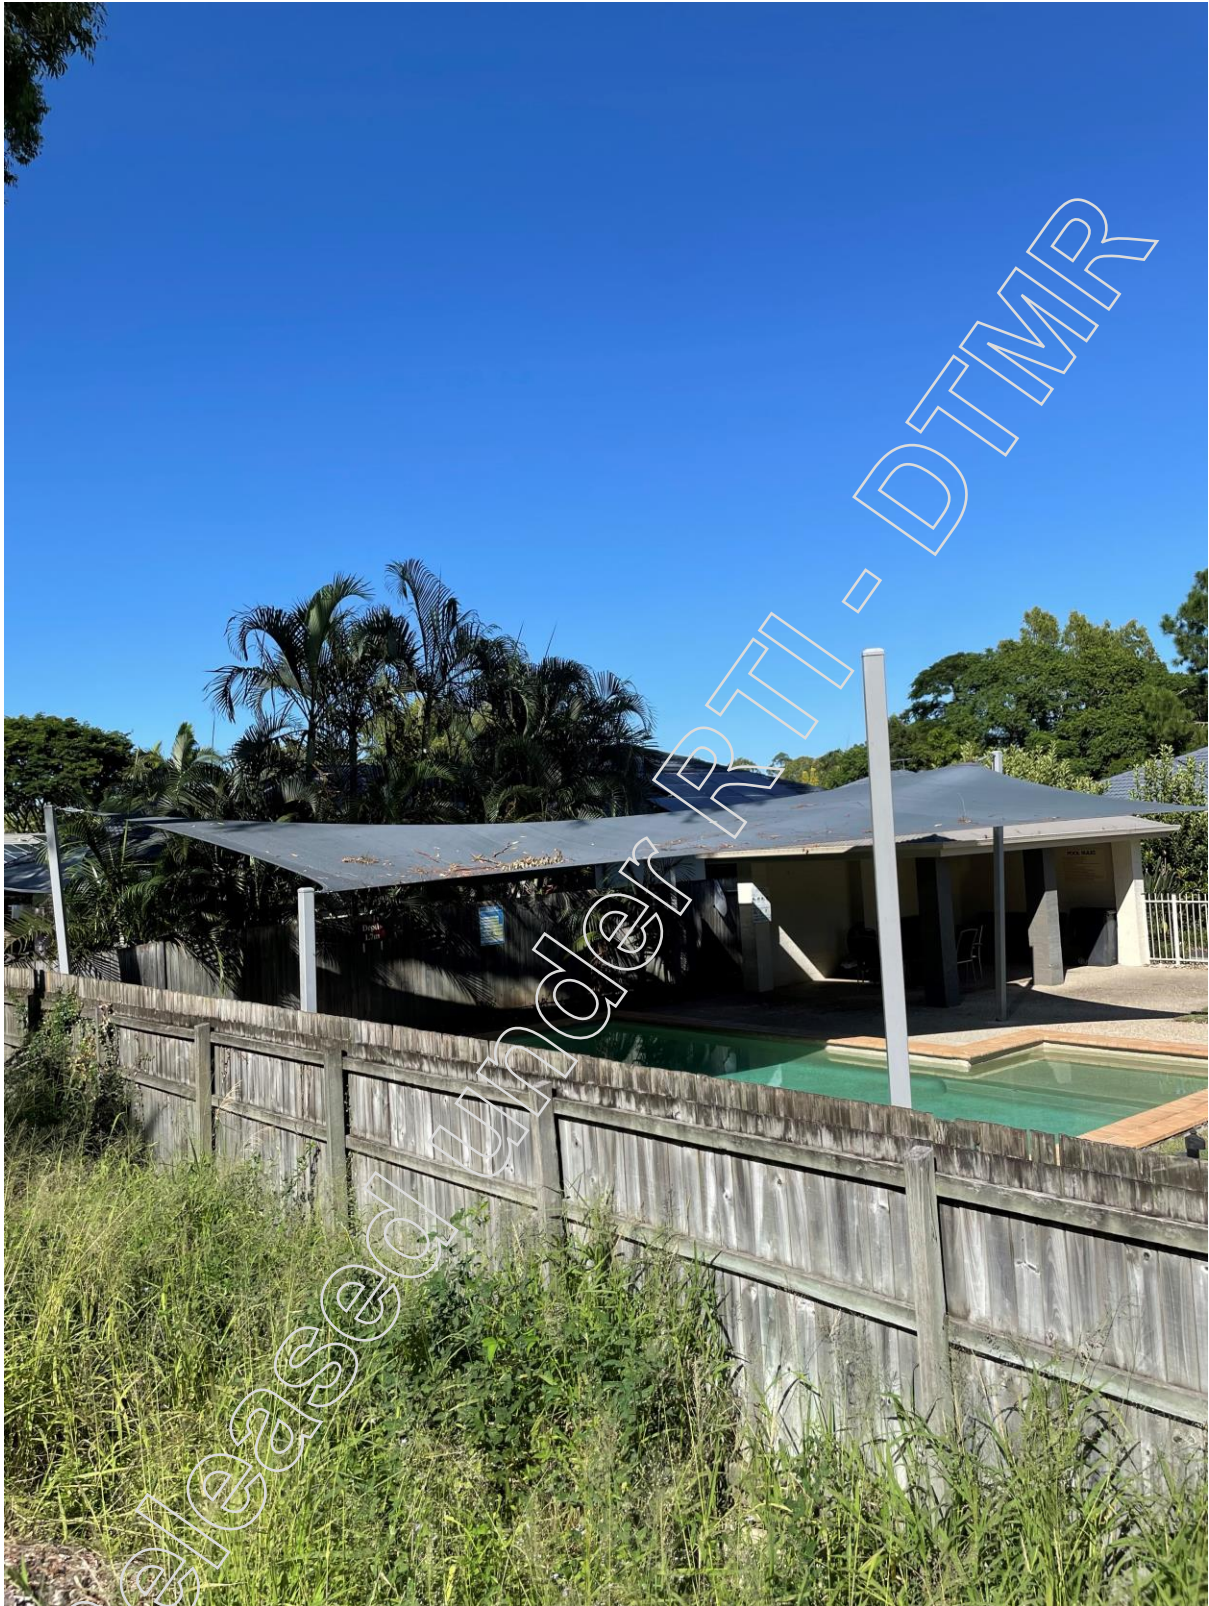
Figure 6 (Shade sail over neighbour's pool) Tree debris present

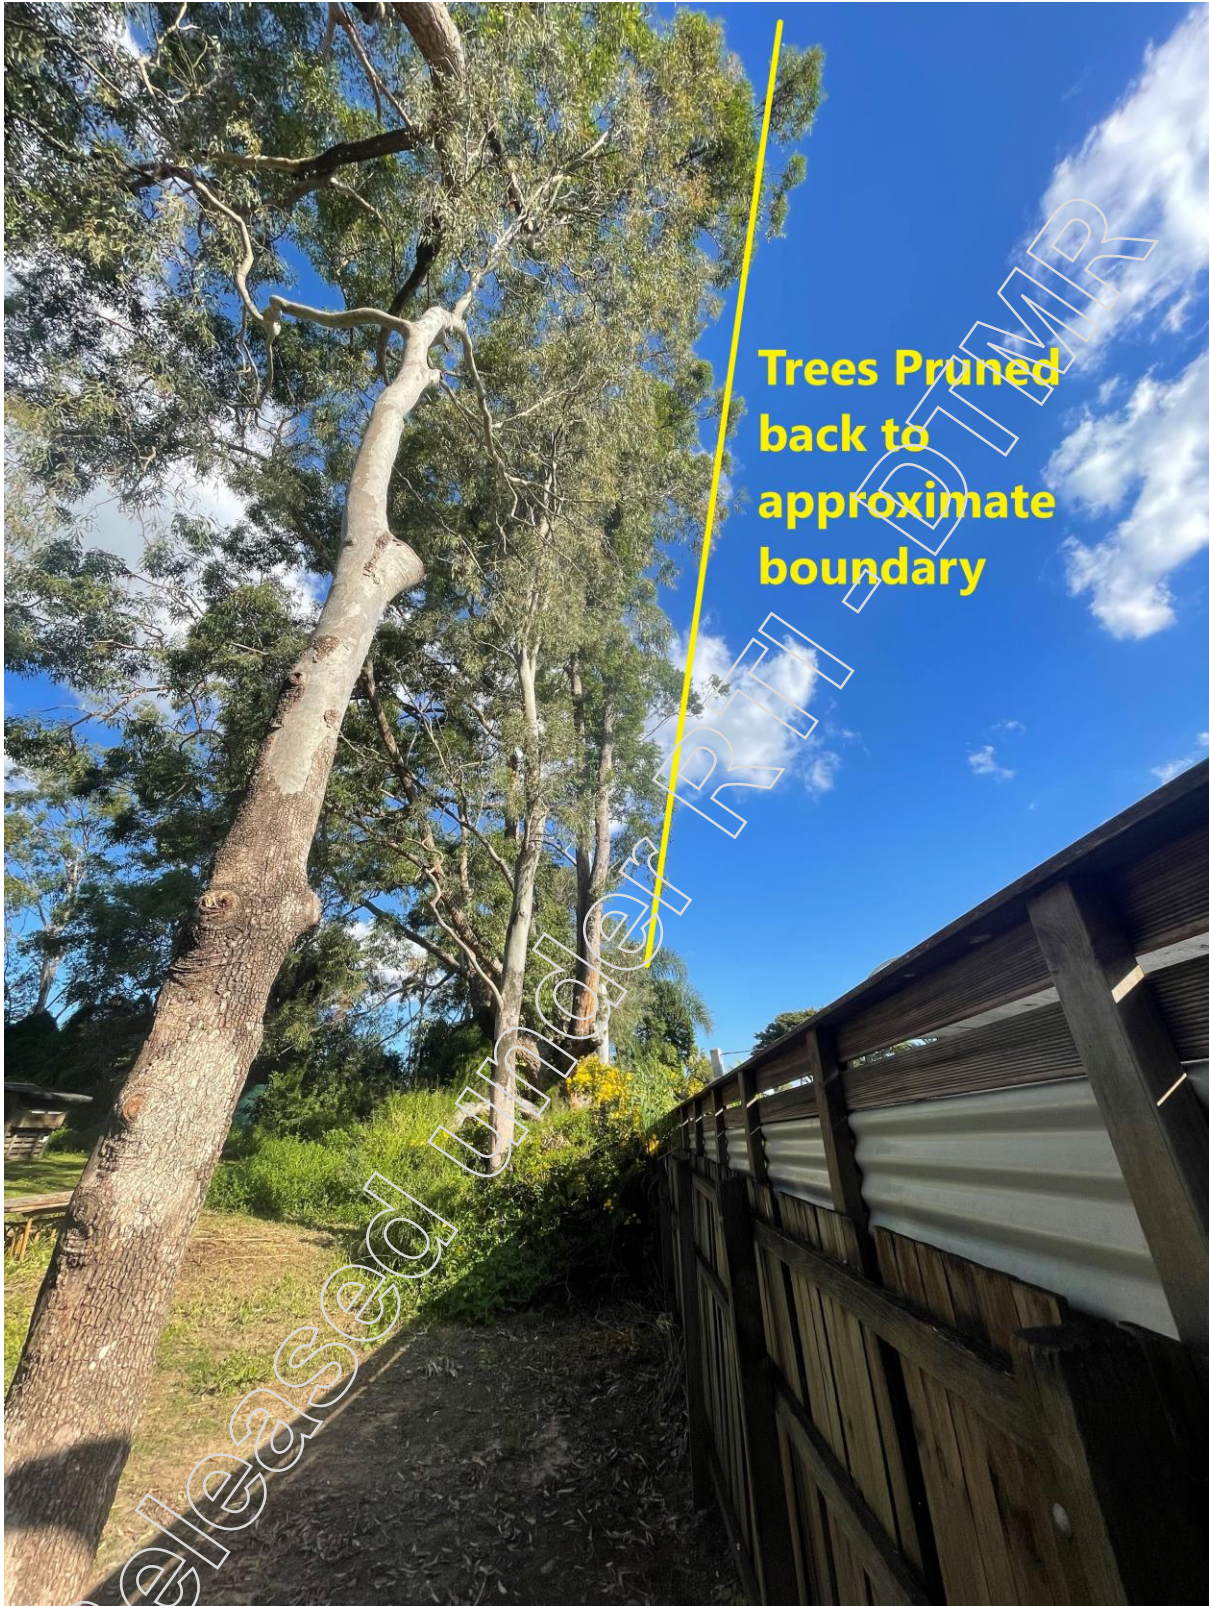
**Trees Pruned  
back to  
approximate  
boundary**
