**TMRSDRS037 Barron River
(Kuranda) Bridge (7799) Brittle
Fracture Assessment &
Management**

**Investigation of Brittle Fracture Risk
and Structure Capacity**

267958/Rep002

Draft 2 | 28 January 2021

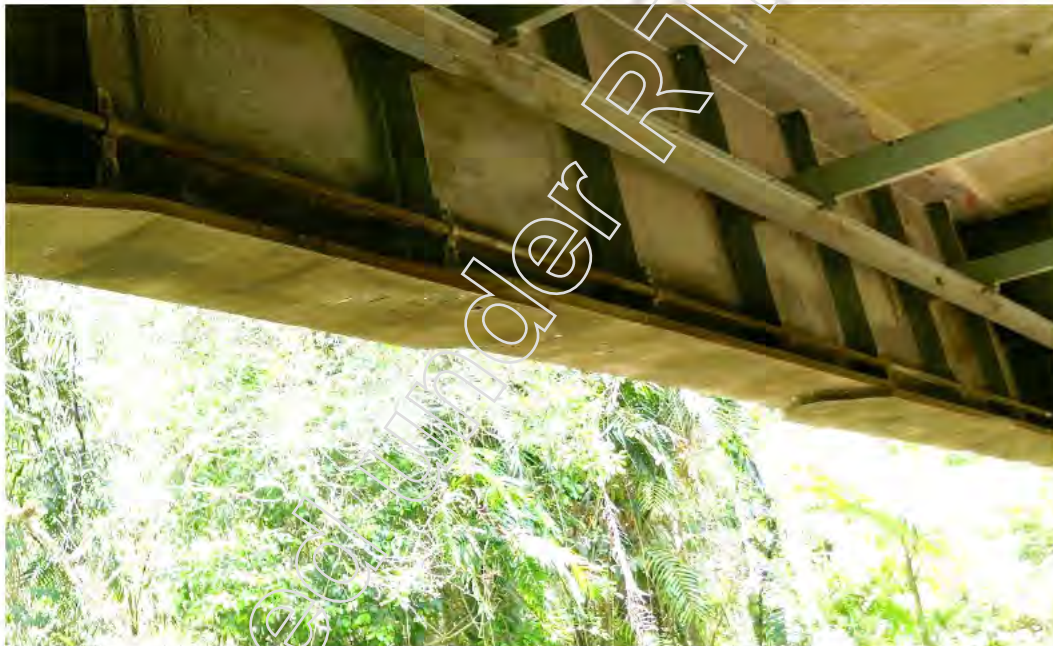
Figure 1: Flange lap joint in span 1.

The primary site and shop splices in the main girders utilise a welded lap detail more typical of the termination of a doubler plate on a steel girder. Instead of joining the plates end on with a transverse butt weld, they are joined by tapered overlapping the plates creating a small step. The sides of the overlap are then welded. This detail is very similar to a standard steel girder cover plate detail where a second plate is added to the flange of a girder in areas of high stress.

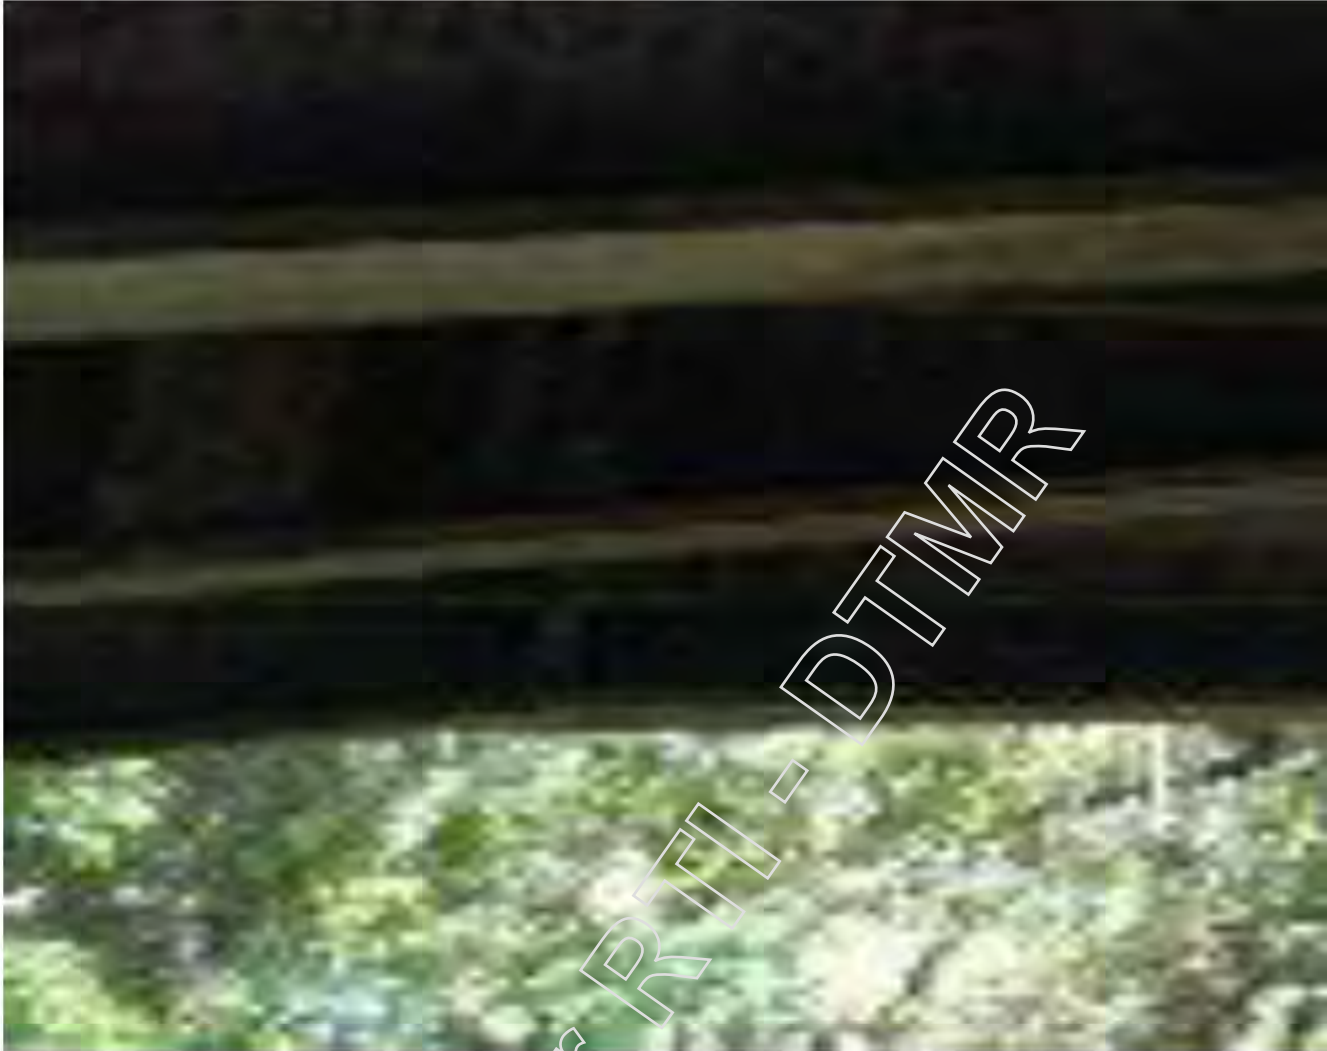
Whilst the Kuranda Bridge was under construction, the Kings Bridge in Melbourne collapsed in July 1962 due to brittle fracture at a cover plate detail. As a result of the failure, the design of the Kuranda bridge was modified with partial removal of welds at the splice joints and the provision of additional external stressed bars to reduce the stresses in the bridge. This work was completed at the end of 1963 after the bridge was opened to traffic. Refer to Figure 2.

Figure 2: Existing bridge and additional Macalloy strengthening added 8 months after opening.

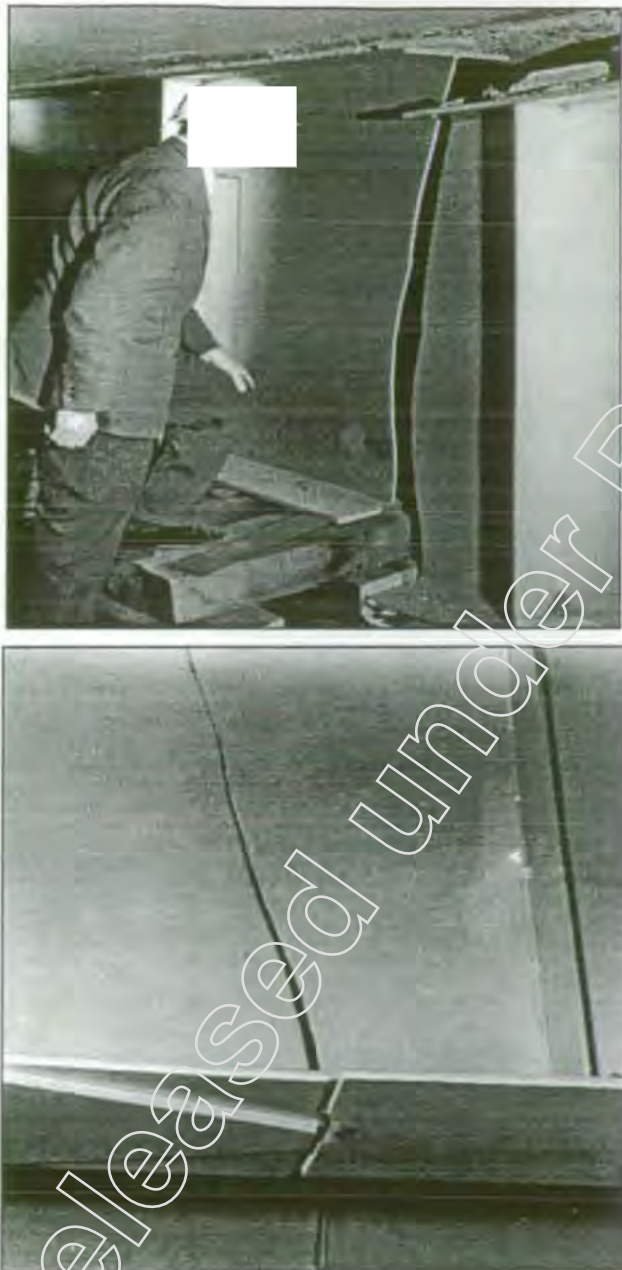
The steel used in the Kuranda bridge possesses adequate yield strength but has a fracture toughness which is significantly lower than would be specified for a structure of this type to modern design standards. At the typical service temperature there is a risk that small flaws or defects in the structure could pose a risk of brittle failure. Similar welded details in Kings Bridge in Melbourne contributed to brittle fracture in the steel girders and the subsequent repairs and strengthening of the bridge at Kuranda. The Kings Bridge fracture is shown below in Figure 3.

Figure 3: Example of brittle fracture at Kings Bridge Melbourne.

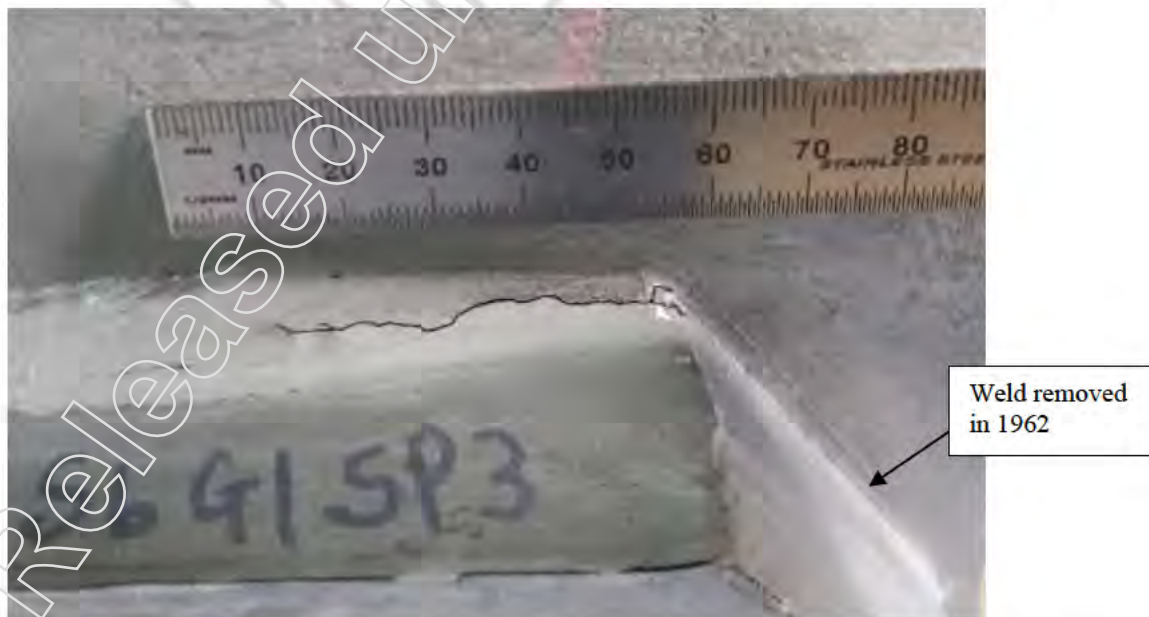
An Arup / TMR targeted visual inspection of likely fatigue crack locations was undertaken on 20th + 21st October 2020 as part of the Arup project brief. During this inspection multiple crack like features were identified in the susceptible lap splice details across the bridge, breaking through the painted corrosion protection.

Figure 4: 53mm crack in span 6 edge girder. Note end fillet weld removed during 1962 strengthening

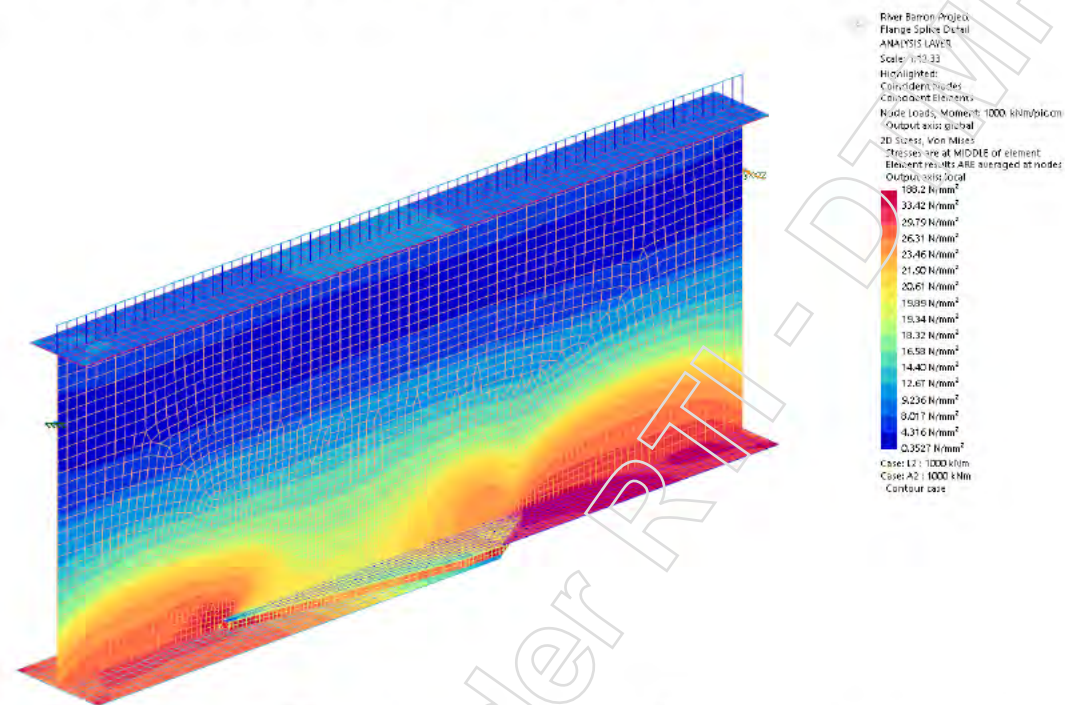
Figure 7: Von Mises Stress in splice detail from 1000 kNm sagging bending moment.

The stresses in the flanges of the FE model are calculated away from the splice detail and compared against a standard section modulus calculation to ensure that the loads applied are distributed to the splice connection as expected. Thus the local effects and stress increases that are determined around the welds can be considered to be representative of the actual bridge.

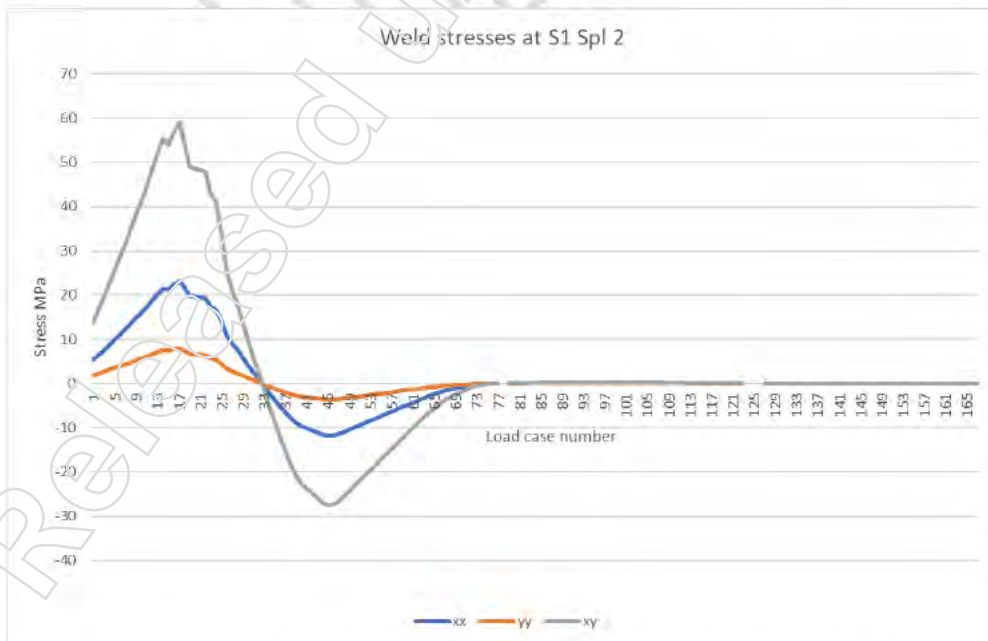
Figure 9: Direct and shear stress spectrum (MPa) at end of weld plotted against vehicle position along bridge (m).

It is noted that the shear stress is significant which is as expected for the fillet weld splice detail.

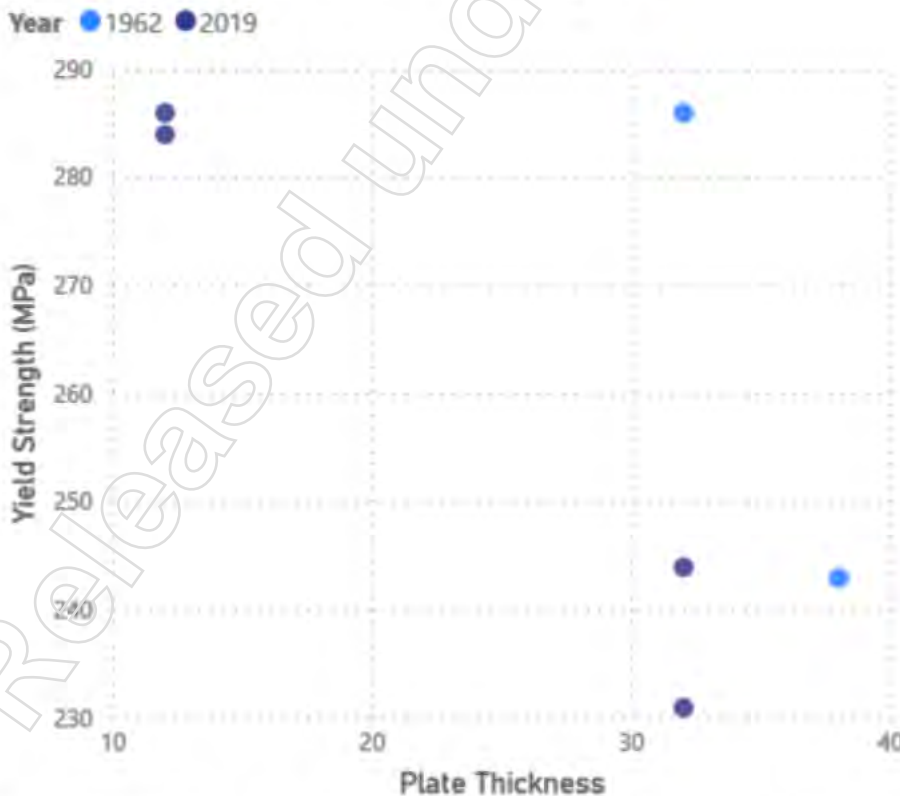
Figure 13: Yield strength test results (tensile) for all plate samples, flange and web.

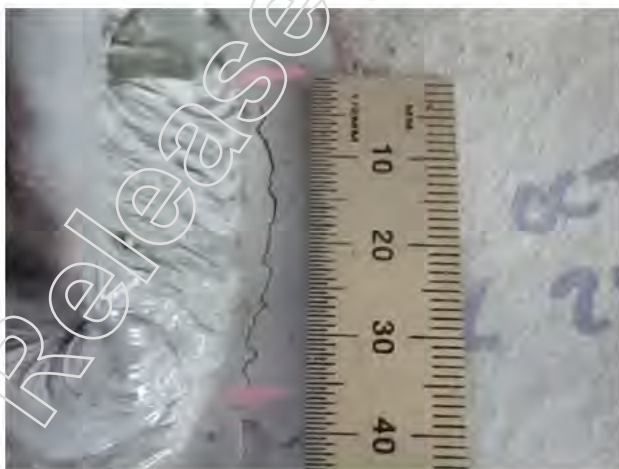
Flaws have been identified at or near the toes of fillet welded attachments to the girder webs. An example is shown in Figure 19 from Cross Girder 3.

Figure 19: Crack at weld toe/HAZ, Cross Girder 3 flange to Web G1.

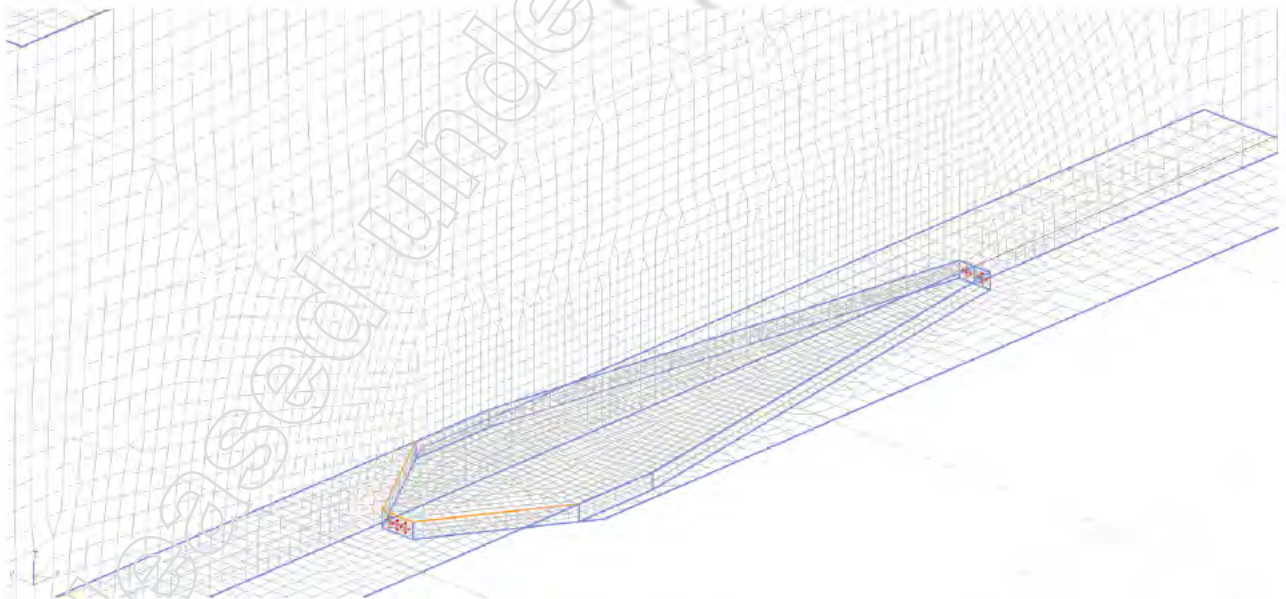
The detailed splice model is shown in Figure 20 below.

Figure 20. Detailed FE model of splice connection.

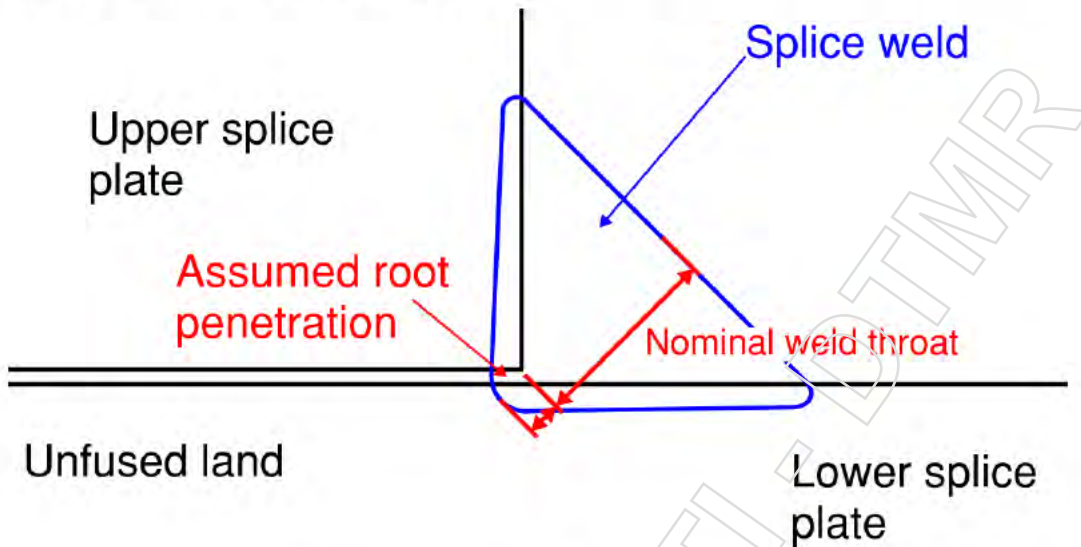
the root exceeds the geometric throat dimension given above. 2mm of penetration at the root has been assumed which is expected to be conservative. The weld geometry assumed is shown in Figure 21.

Figure 21: Assumption on geometry of splice weld

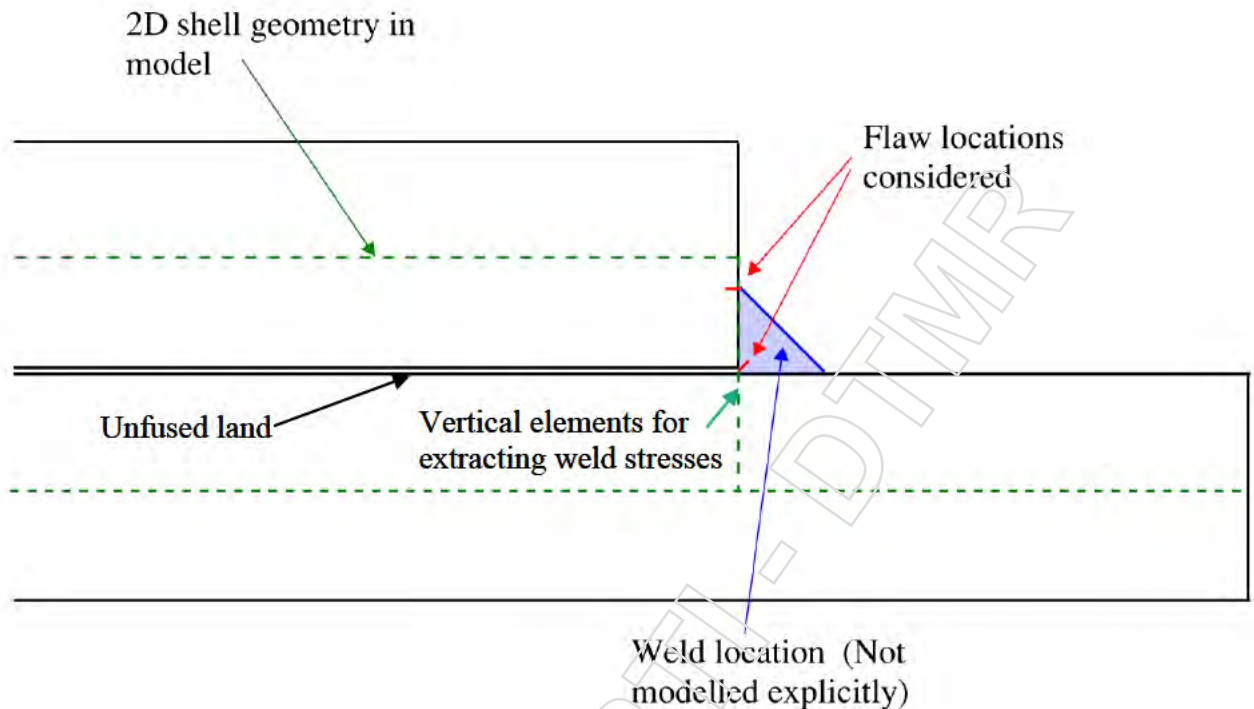
The principal stress extracted from the model is therefore determined based on the forces transferred through a stress area equivalent to the effect throat of the weld. When remedial works were undertaken in the 1960s to remove the weldment from the transverse ends of the splice plates, the remaining weld along the longitudinal edge of the splice plates was tapered, this detail can be seen in Figure 15. To account for this, the initial portion of each weld (100mm) has been tapered by reducing the thickness of each element incrementally down to 5.4mm at the start of the weld which corresponds to a reduction in the weld leg of 50%. Therefore, the stresses used in the ECA account for the weld area. Significant magnification of stress is therefore seen compared to the adjacent plate.

Figure 22: Graphic showing 2D model representation of splice weld detail

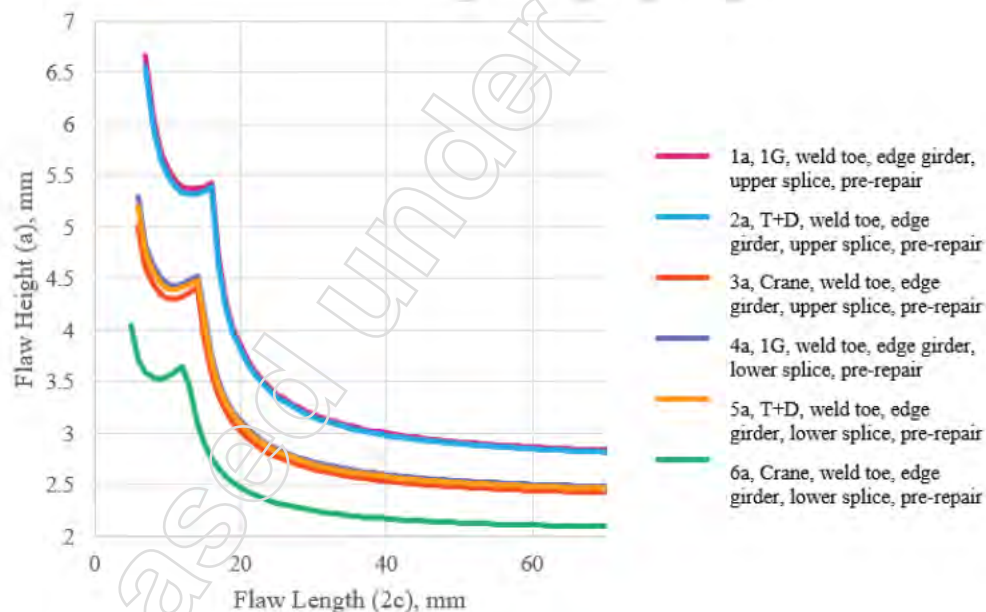
Figure 27: Critical flaw height versus length for flaws at the weld toe of edge girder, bottom flange splice welds before repair/grinding. Upper and lower splices shown for all vehicles.

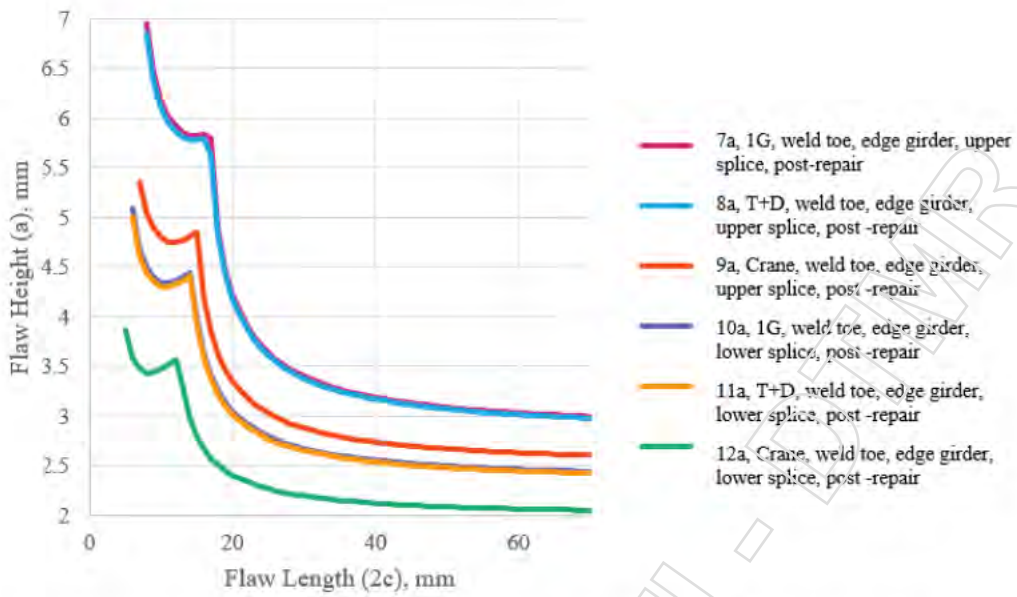
Figure 28: Critical flaw height versus length for flaws at the weld toe of edge girder, bottom flange splice welds after repair/grinding of 100mm of weld. Upper lower splices shown for all vehicles.

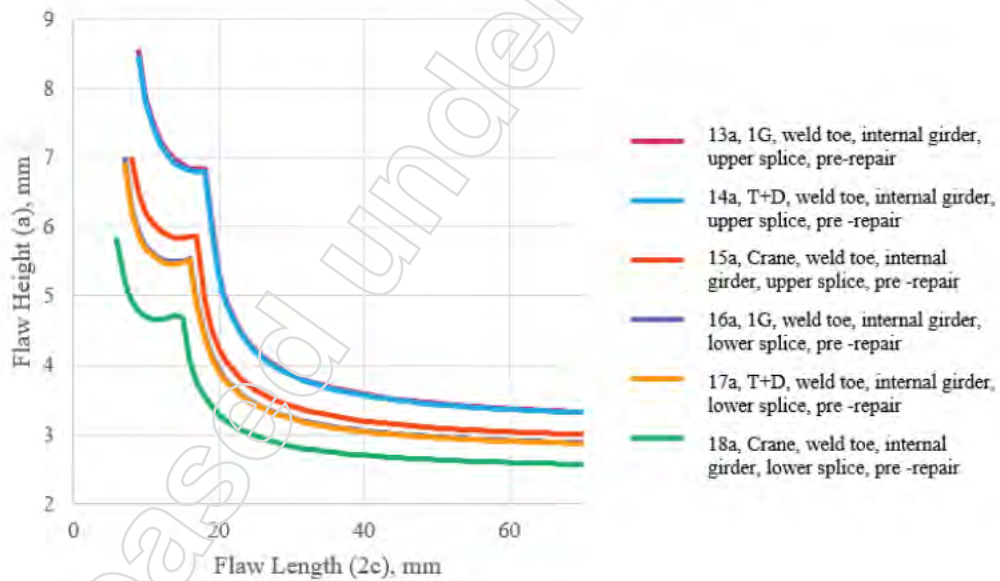
Figure 29: Critical flaw height versus length for flaws at the weld toe of internal girder, bottom flange splice welds before repair/grinding. Upper lower splices shown for all vehicles.

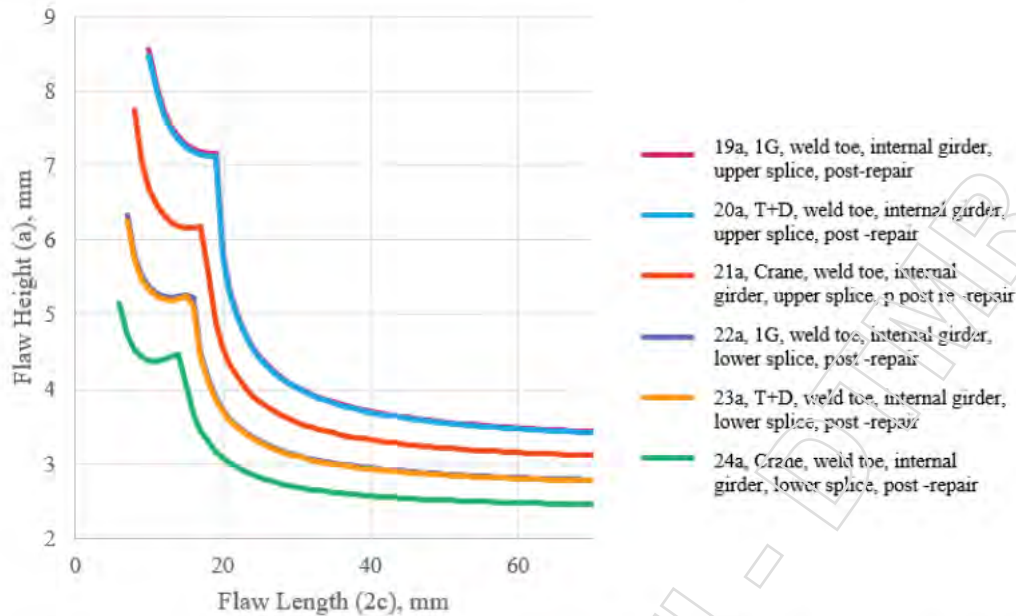
Figure 30: Critical flaw height versus length for flaws at the weld toe of internal girder, bottom flange splice welds after repair/grinding of 100mm of weld. Upper lower splices shown for all vehicles.

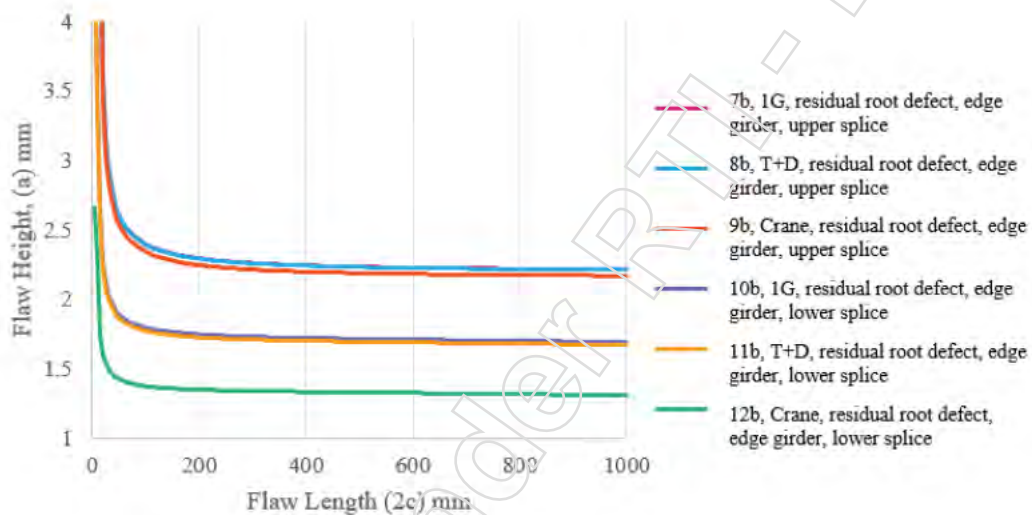
The following figure shows the sensitivity of critical flaw height to flaw length along the remaining weld root. As the length of the remaining defect is difficult to detect, these charts show the acceptable residual flaw height for long residual defects.

Figure 31: Edge girder, critical flaw height versus flaw length for residual root defects after grinding.

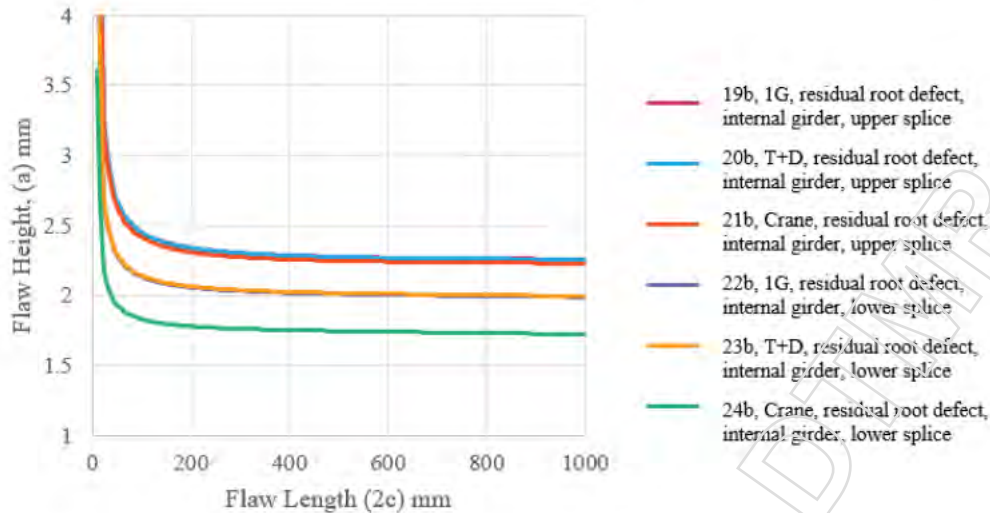
Figure 32: Internal girder, critical flaw height versus flaw length for residual root defects after grinding.

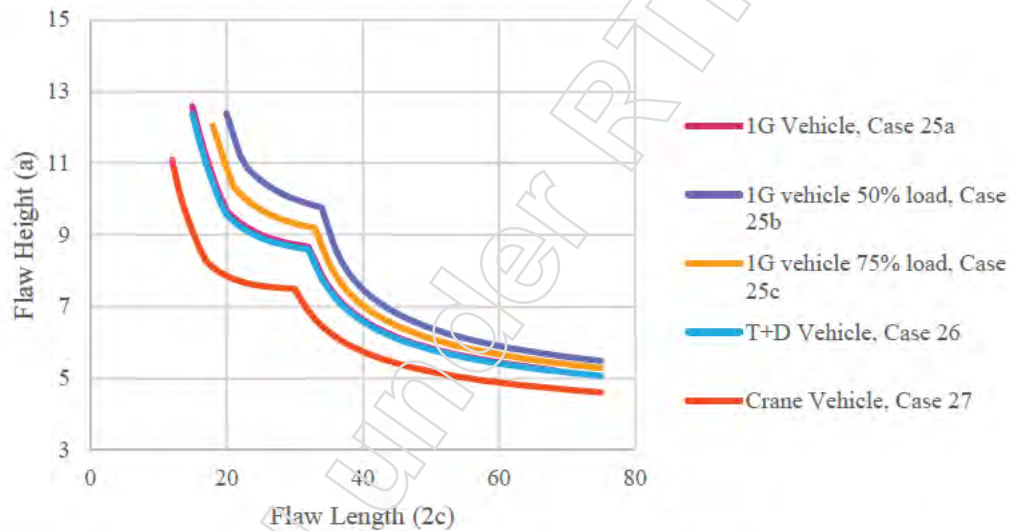
The following figures shows the sensitivity of critical flaw height to flaw length for flaws at the toe of stiffener welds on the cross girders.

Figure 33: Critical flaw height versus length for flaws at the weld toe of connections to the cross girder web.

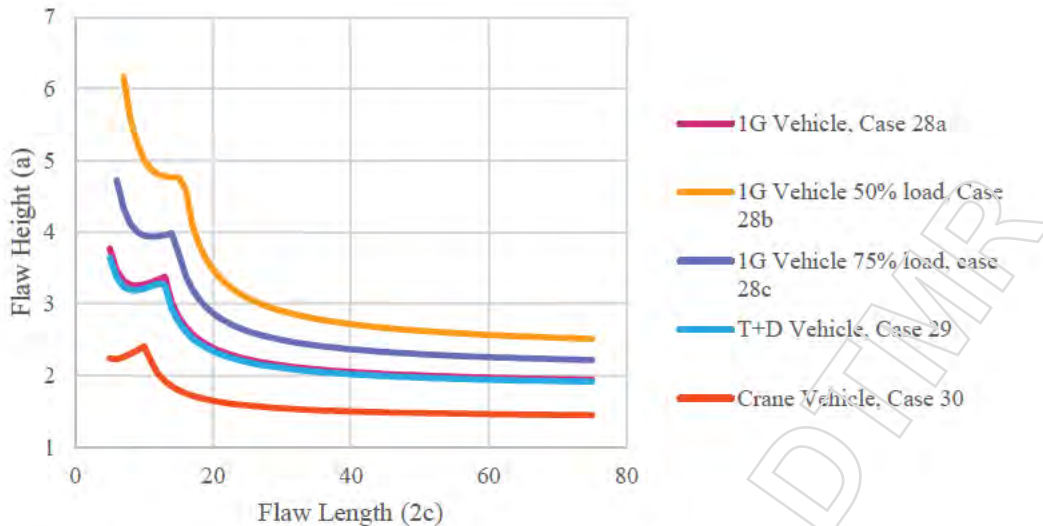
Figure 34: Critical flaw height versus length for flaws at the weld toes of connections to the bottom flange of cross girders.

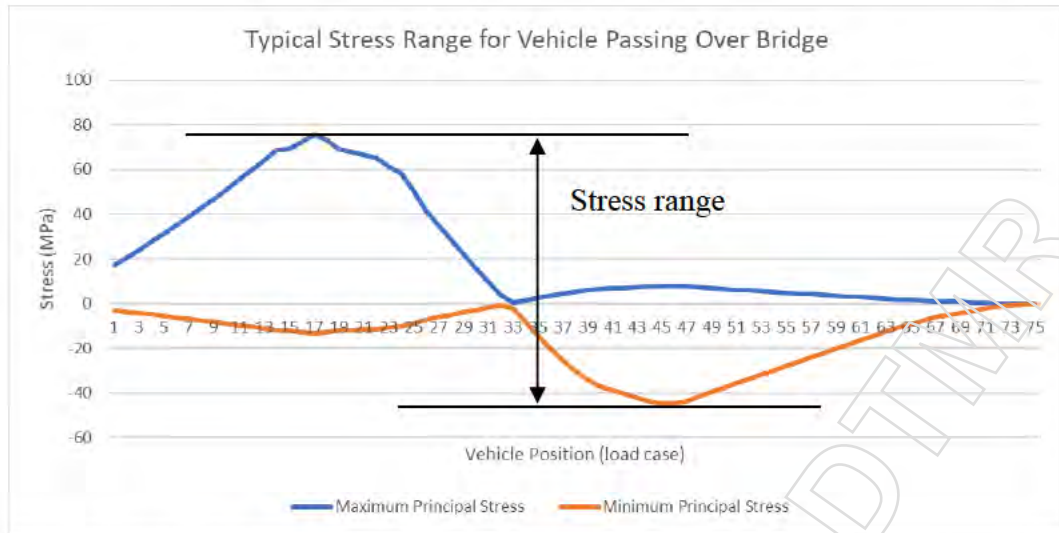
For the fatigue assessments, stress spectra are derived from the finite element models discussed in Sections 4 and 5.3. As a vehicle moves over the bridge, the stress at the flaw location varies as shown in Figure 35. The stress range extracted from the models typically includes a tensile portion and a compressive portion of the cycle. For flaws located in the weldment or HAZ, and subjected to tensile yield magnitude residual stress, the full stress range must be considered as damaging. The effect of superposing the fatigue stress on the residual stress is illustrated in Figure 36.

Figure 35: Typical stress range for fatigue calculation

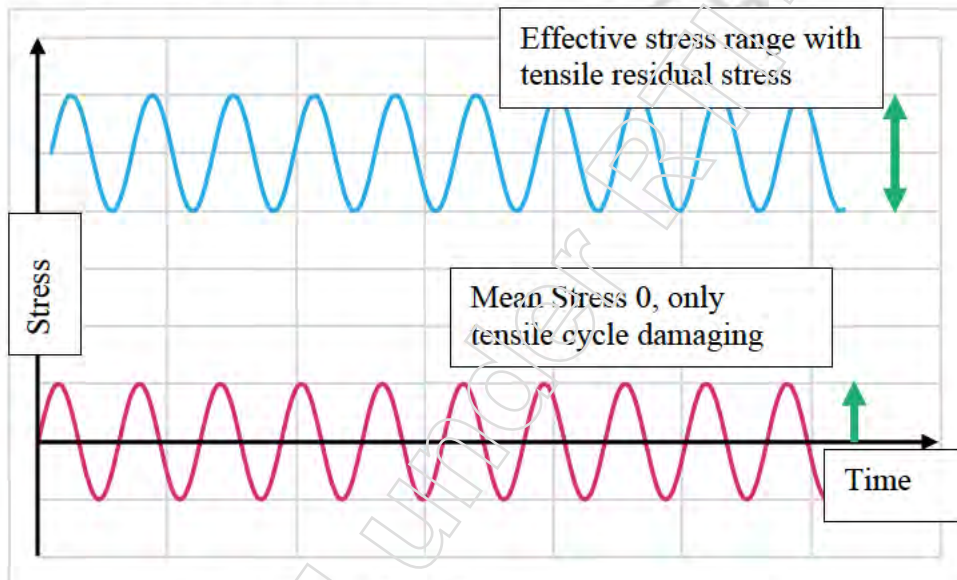
Figure 36: Effect of tensile residual stress on damaging portion of stress cycles.

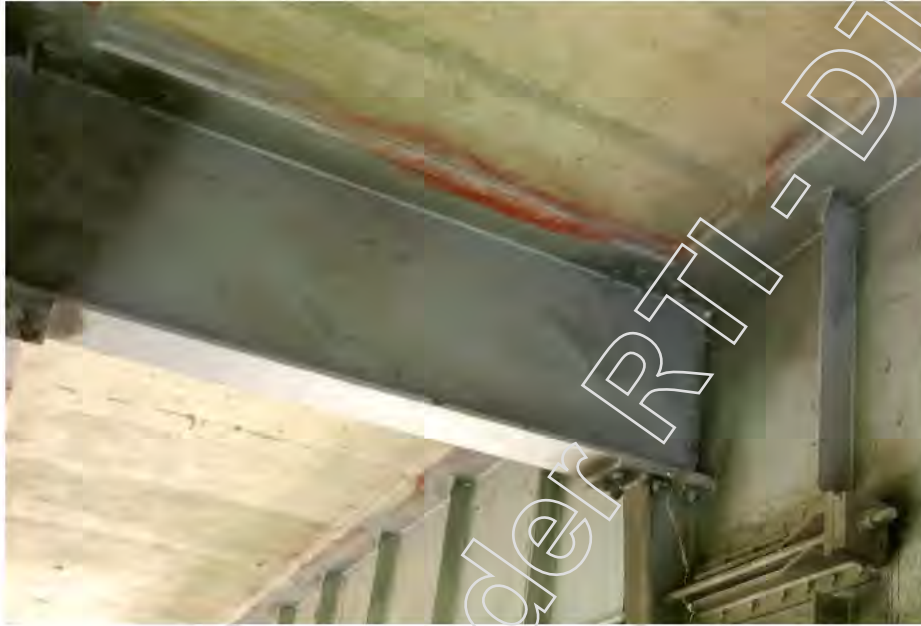
The ability of the cross girders to distribute load is governed by the strength of the TB/ TF connections which connect the cross girders to the main girders. As discussed previously the connecting plates are slotted through the main girders and the cross girders are fully continuous across the bridge.

Figure 40: Typical internal cross girder member and connection.

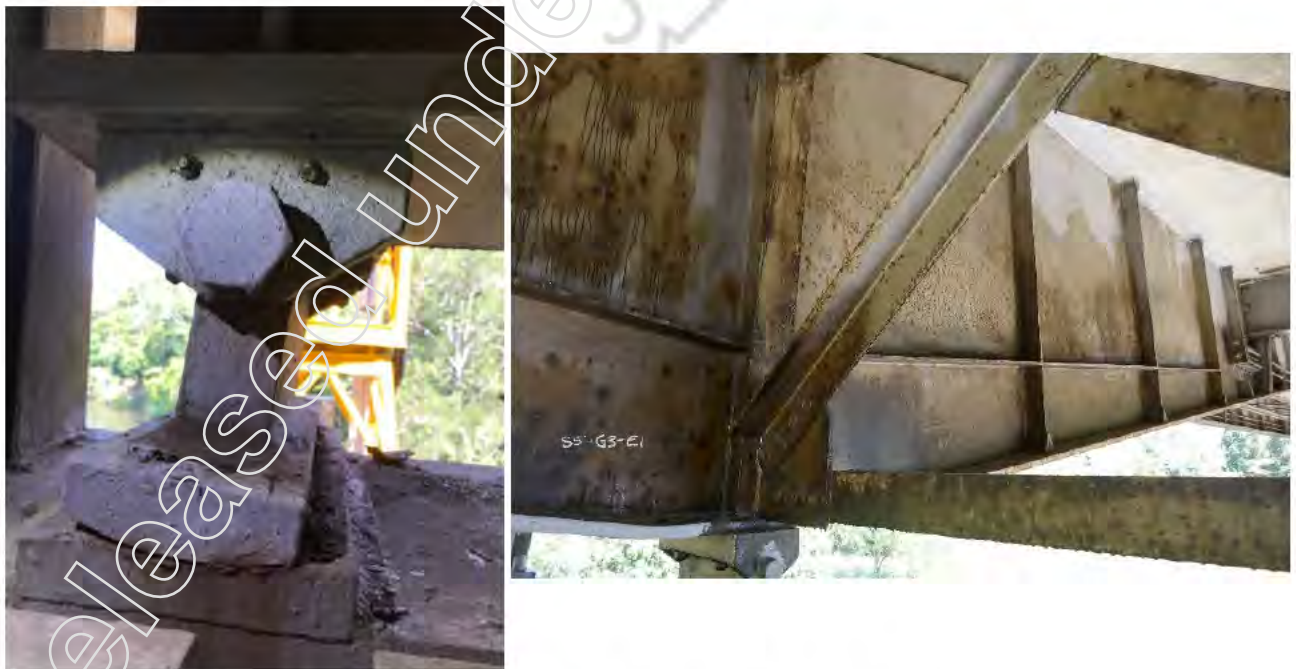
Figure 42: Existing rocker bearings on bridge and corrosion on the steelwork

These items need to be included in the development of the long-term management plan for the bridge.
