## Arboricultural Report Pertaining To 220 Albany Creek Rd, Bridgeman Downs.

**Client:** TMR

**Site:** 220 Albany Creek Rd, Bridgeman Downs.

**Inspection Date:** 18 Feb 2022

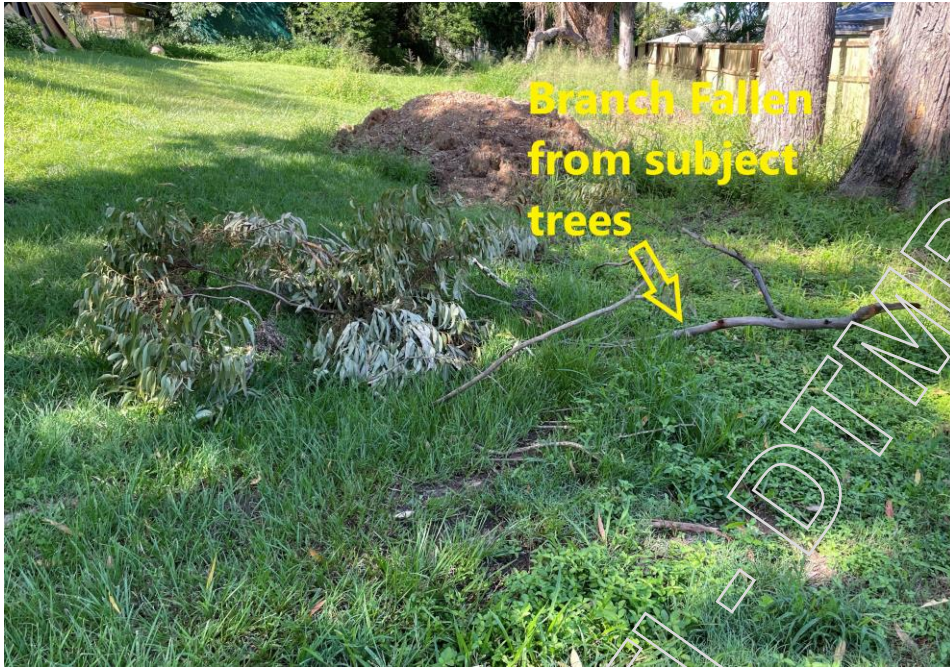
Figure 3

Due to what appears to be a wind event that has caused minor branches to fail within the upper canopy. These branch failures have left lodged limbs in the canopy. These limbs should be pruned and removed from the canopy to remove the risk they hold to occupants below.

It is recommended that the hangers in the canopy of these trees be pruned out and these trees be assessed on an annual basis given their maturity and position within the landscape.
