Technical Note 103

Vandalism of Plastic Pipe under Roads, Rail and Similar Infrastructure

July 2019

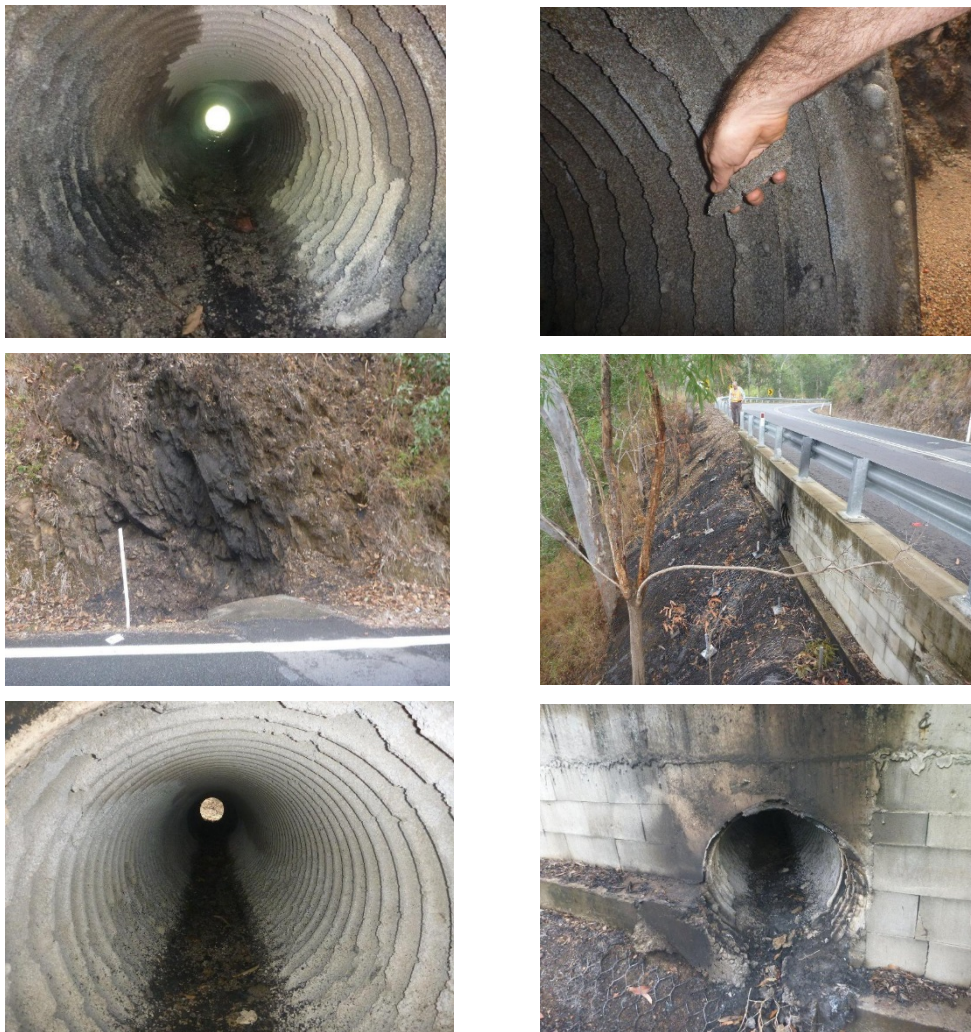
Figure 1.2 – Vandalised pipes

Following routine inspections in 2013 at various locations throughout the state, it has been identified plastic pipes, used for drainage below the roadway, have been subjected to systematic vandalism by fire. These events have been occurring in rural and urban areas.

Effective September 2013, due to the unacceptable level of risk to road users, underground plastic pipes are not to be used in new construction projects.

Grout filled enveloper pipe is not included in the withdrawal of drainage plastic pipes. Additionally, in some rare occasions where polyethylene pipes may be suitable in future, the pipe shall be fully encased in structural concrete and the pipe designed in accordance with AS/NZS 4131.
